LAND CRUISER 2F HEAD REPLACEMENT

Notes on Mark Dixon's '79 2F engine

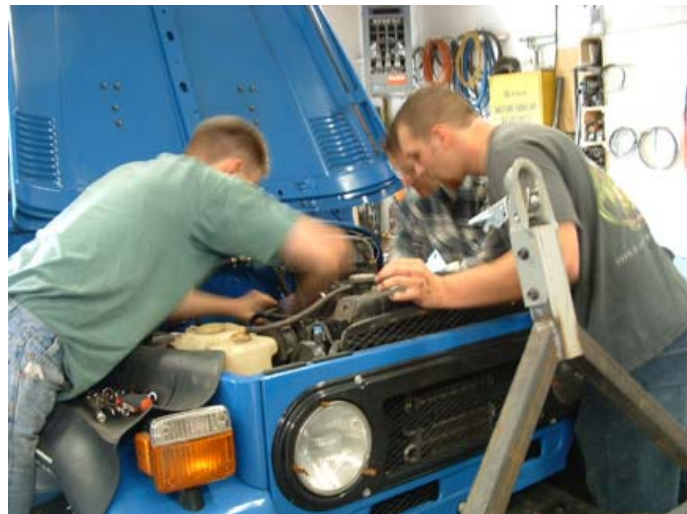
1 - 30 !?!?!

Once the low compression was identified, the cause can be determined with some certainty by performing a “wet” test. This is done by adding a few squirts of oil in the cylinder and rerunning the compression test. The results did not show an increase in pressure in cylinder #1. Logically, low compression happens when air escapes from the combustion chamber abnormally. By performing the wet test, the piston rings feature extra sealing capability. Because air would not “blow by” the piston rings during the wet test (unless the rings were damaged severely), there is confidence in stating that the air/gas mixture is escaping through one of the valves or between the head and head gasket.

The head was pried loose and lifted carefully from the block. Because the 2F head is very heavy, 3 people were needed to safely lift it off the block. Upon inspection, the exhaust valve for cylinder 1 was burned through, resulting in the loss of compression. All other valves looked to be in good shape (just some minor carbon buildup).

Valve burned completely through exhaust valve.

Through the process of elimination, it was determined that the head needed replacement. Dixon had a head machined (ground valves and seats, new valve guides, and new valve stem seals). The date was set to perform the replacement 6/12/04.

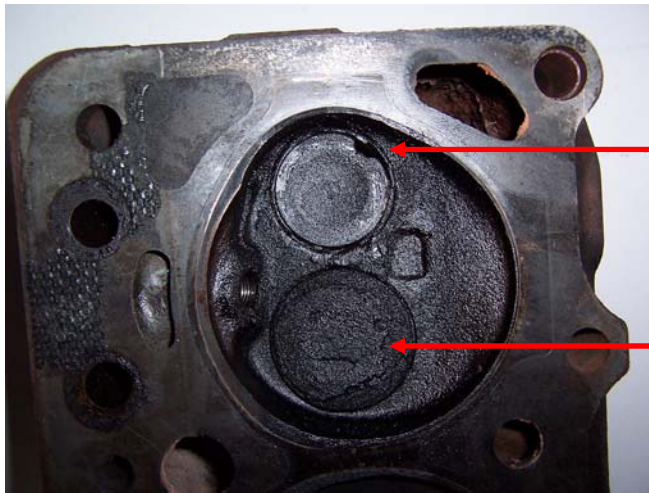
Heavy carbon buildup on intake valve.

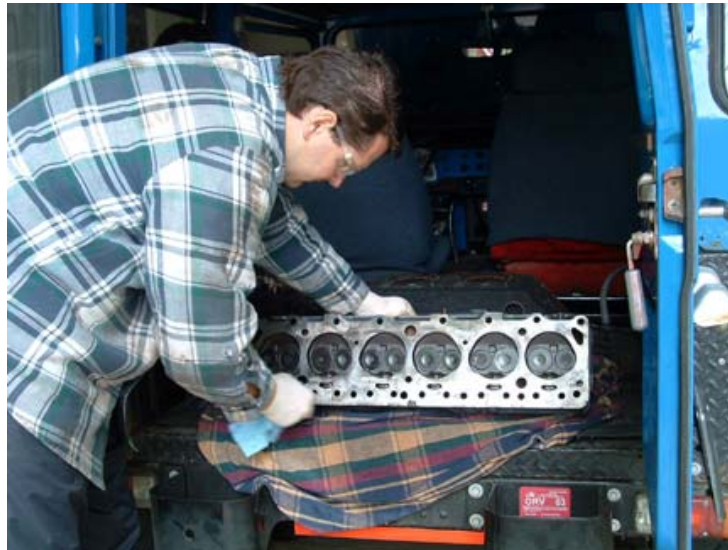
The mating surface was cleaned to remove all contaminants.

To prepare the block for the new head, the old gasket material was completely removed by scraping with a chisel. It was important that all material be removed or the head would not seat well. Carb cleaner was used to aid the gasket removal process and to insure all grease and oil was eliminated. Carb cleaner was also used to remove the carbon buildup on the piston of cylinder 1, and to prepare the mating surface of the new head...
